## PHOTOGRAPH LOG

<b>Project Name:</b> Gold King Mine	<b>Site Location:</b> Silverton, San Juan County, Colorado	<b>Project No.</b> 0001/1408-01
--	---	------------------------------------

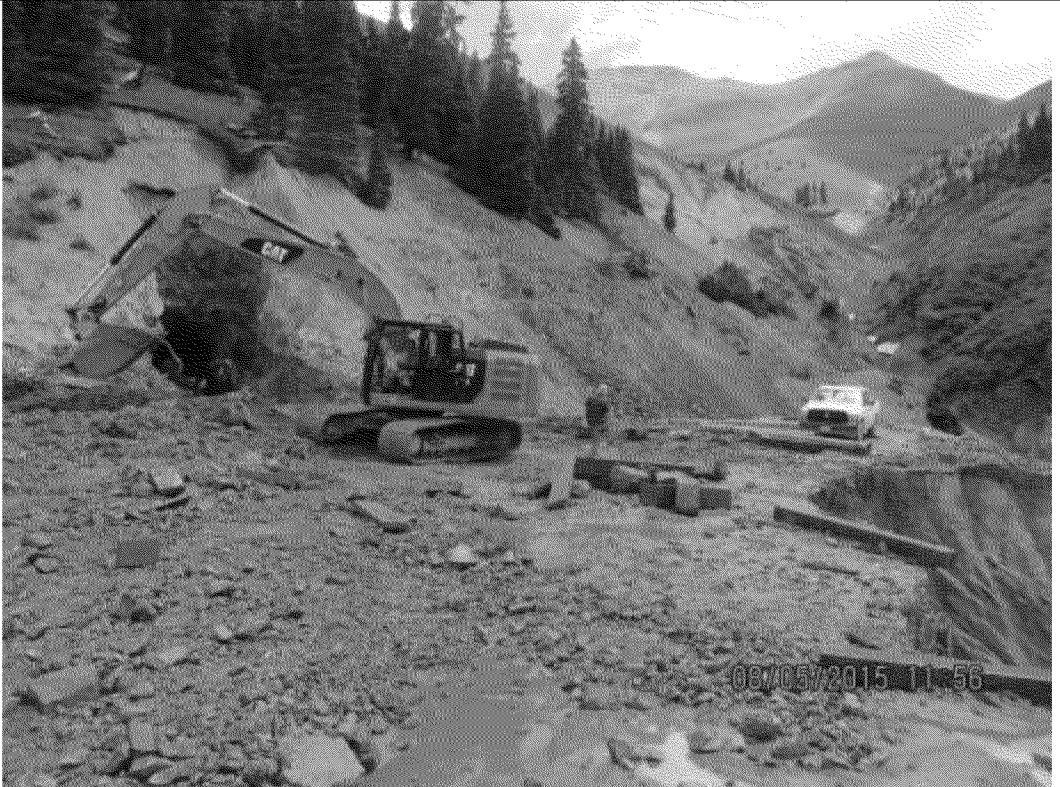
08/05/2015 11:56
<b>Direction Photo Taken:</b> Northeast	<b>Description:</b> Excavator redirecting water into existing half-pipe channel.	
<b>Photo No.</b> <b>30</b>	<b>Date:</b> 08/05/2015

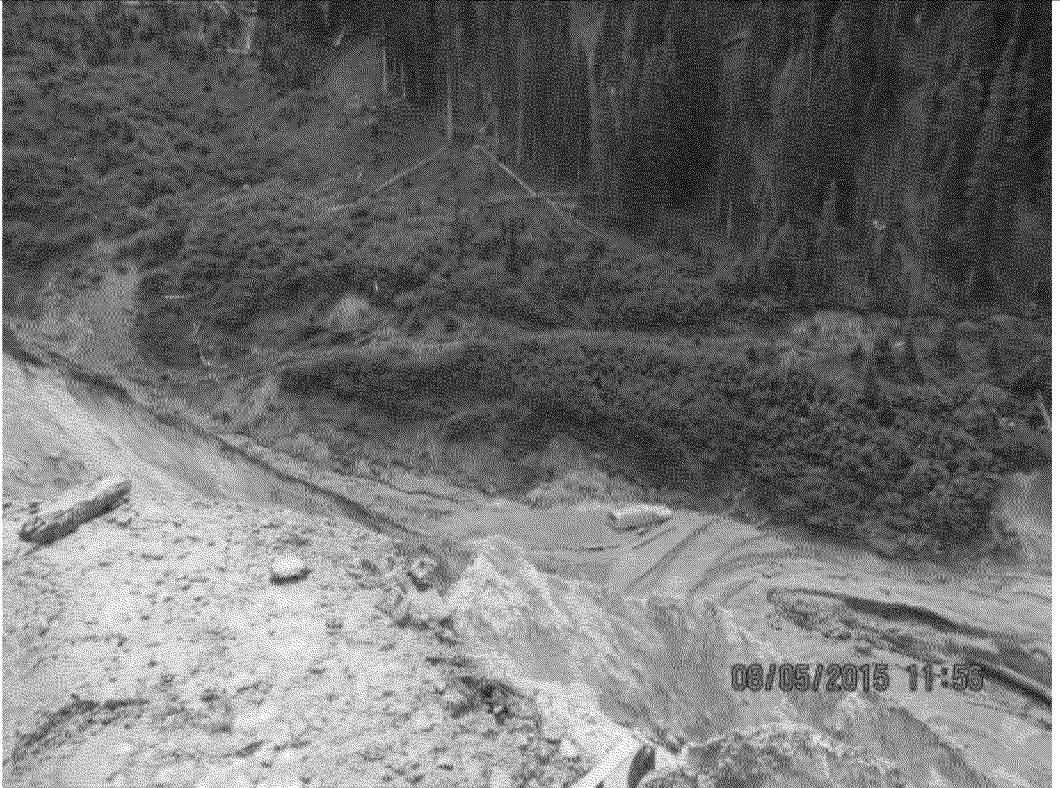
08/05/2015 11:55
<b>Direction Photo Taken:</b> Southeast/Down	<b>Description:</b> Collapsed portion of waste dump and road wash out.

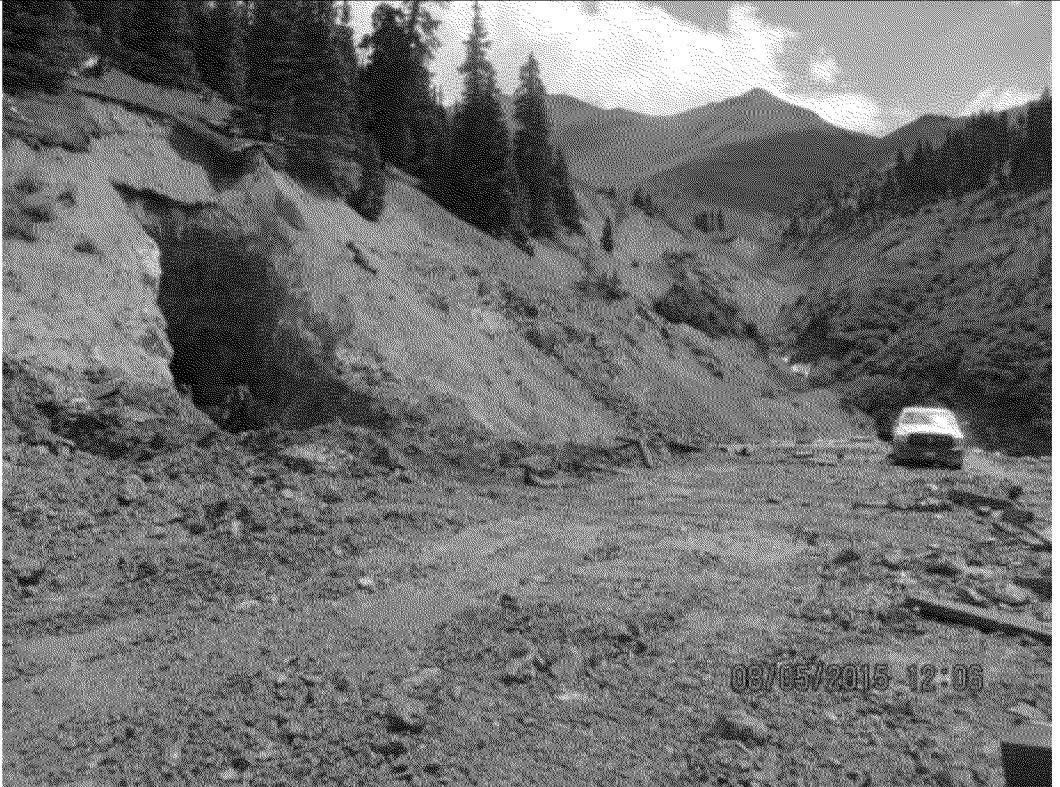
<b>Description:</b> Adit area after regrading.			
Photo No. <b>32</b>	Date: 08/05/2015	<b>Direction Photo Taken:</b> North

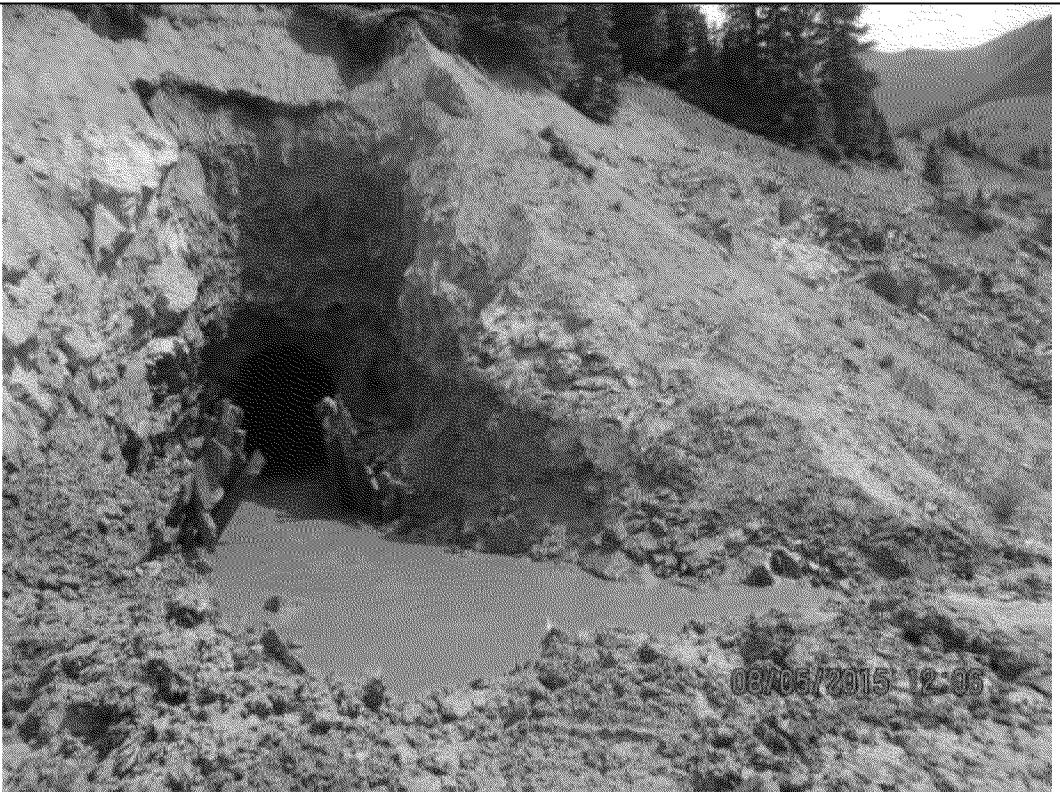
<b>Description:</b> Exposed adit and redirected flow, flow is beginning to subside.

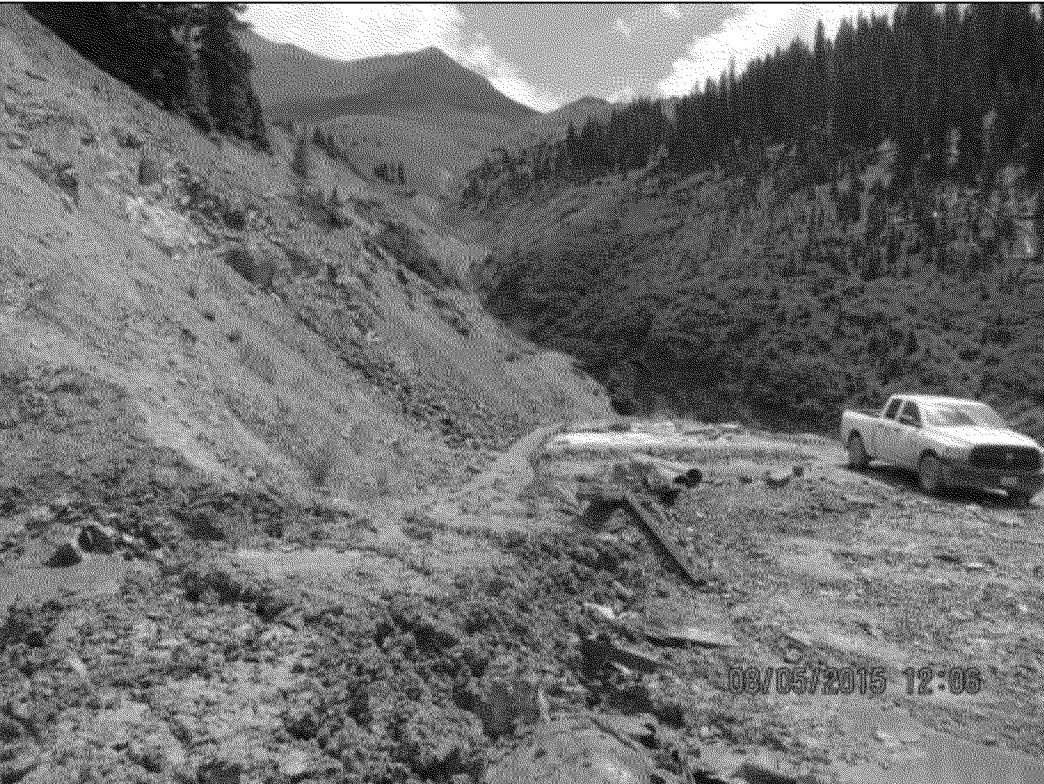
Direction Photo Taken:	East		
Description:	Redirected flow into existing half culvert channel.		
Photo No. <b>34</b>	Date: 08/05/2015

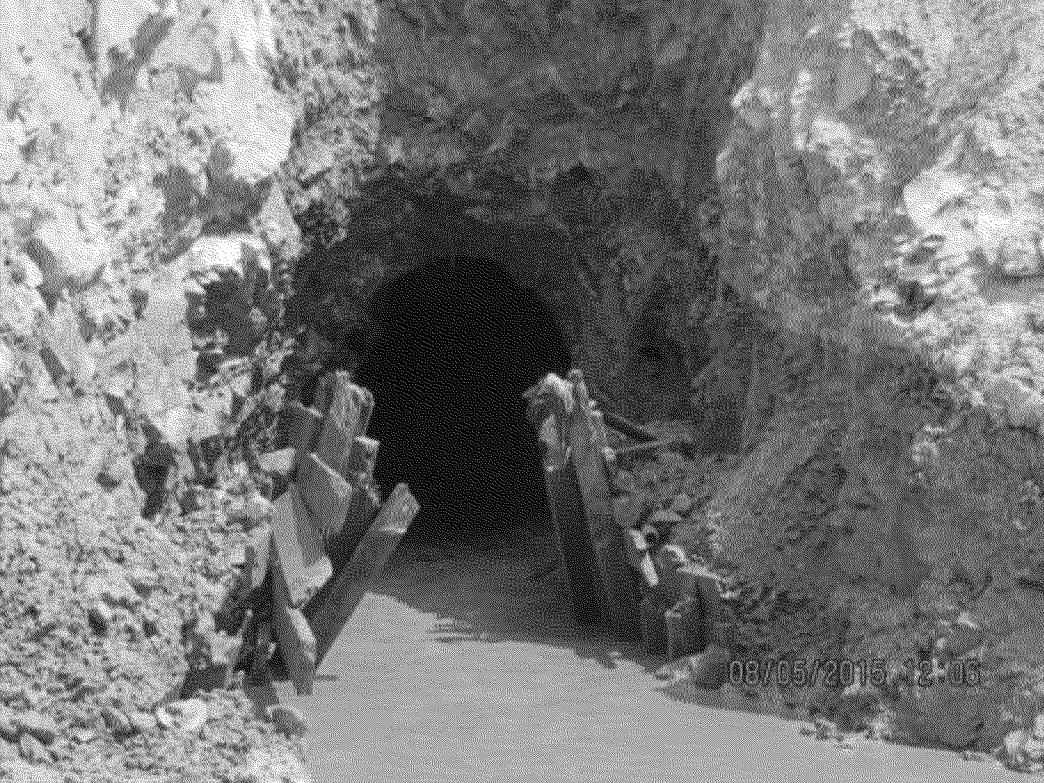
Direction Photo Taken:	North		
Description:	Closeup of adit.

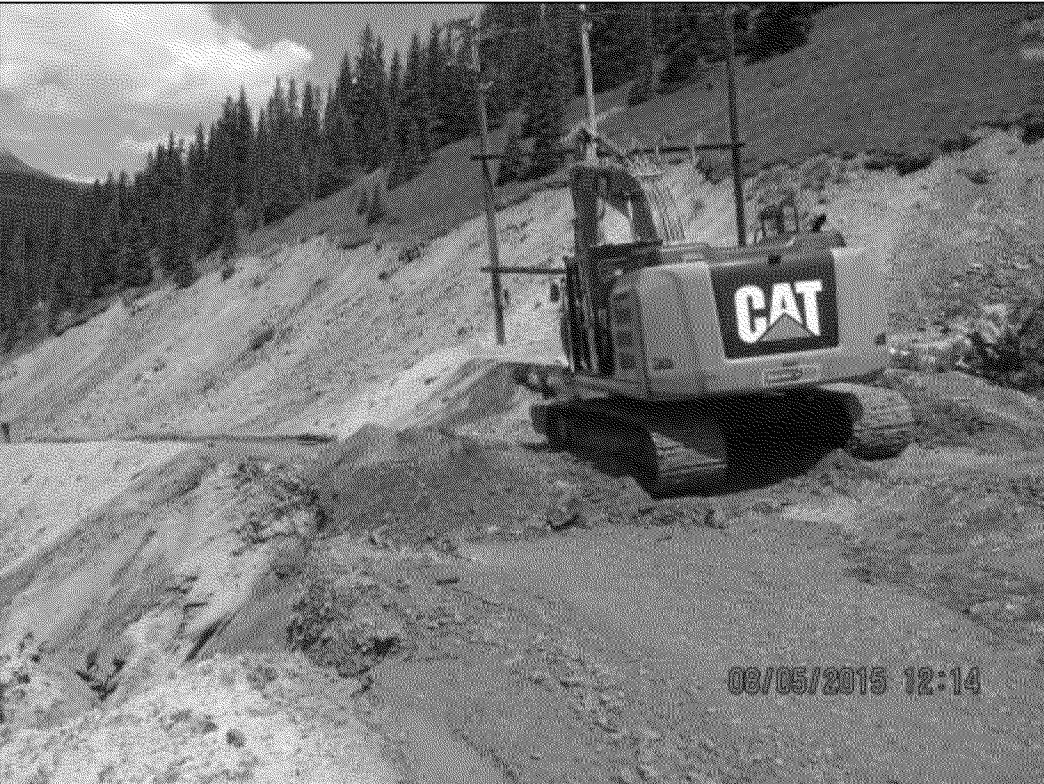
08/05/2015 12:14
<b>Description:</b> Excavator beginning work to secure safe exit route for equipment, vehicles, and personnel.

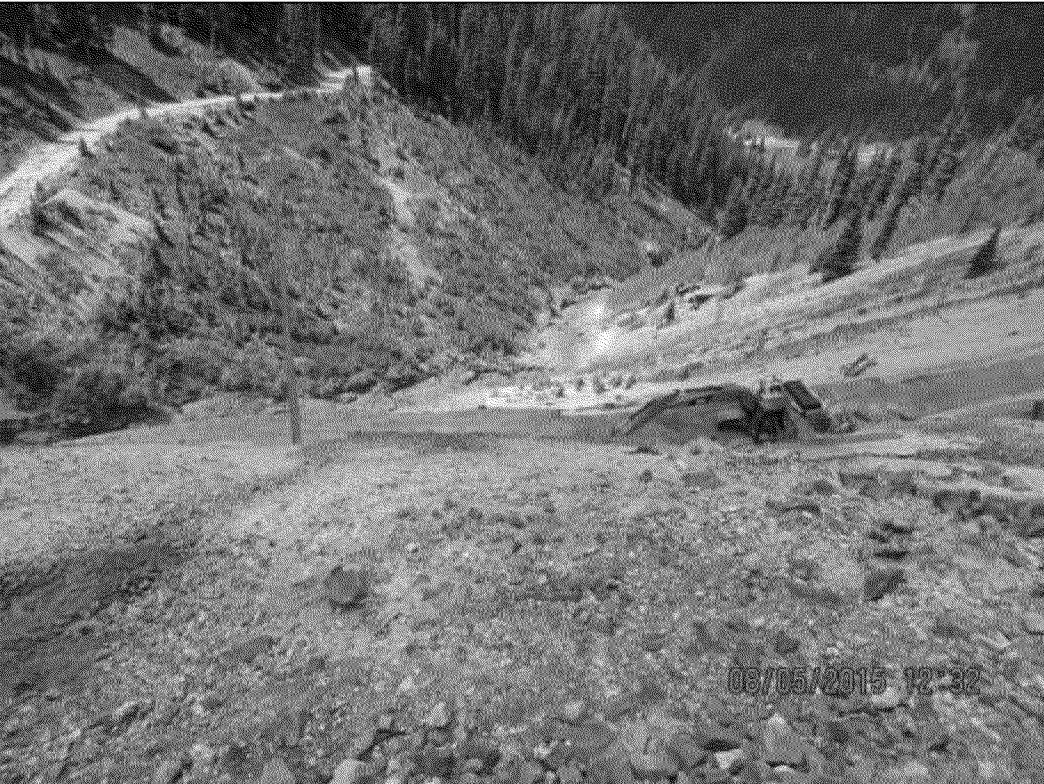
Direction Photo Taken:	Southwest/Down		
Description:	Excavator progress on fixing access road to create a safe exit route.		
Photo No. <b>38</b>	Date: 08/05/2015

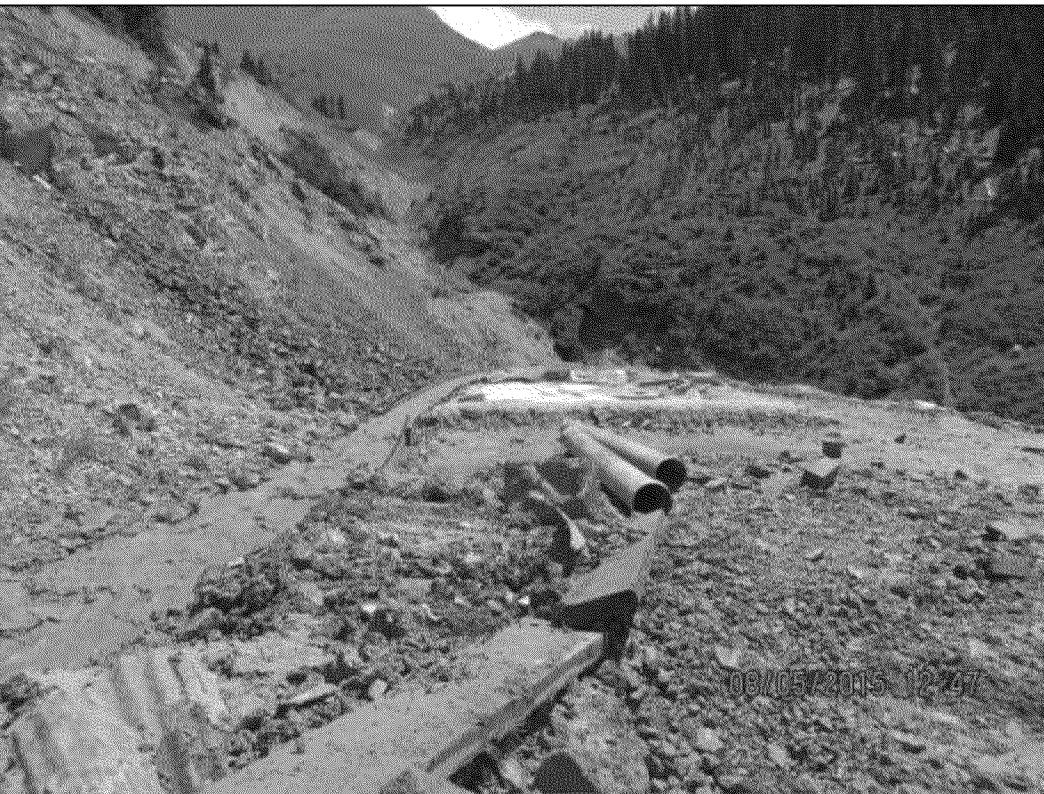
Direction Photo Taken:	East		
Description:	Existing culvert flows subsiding minimally.

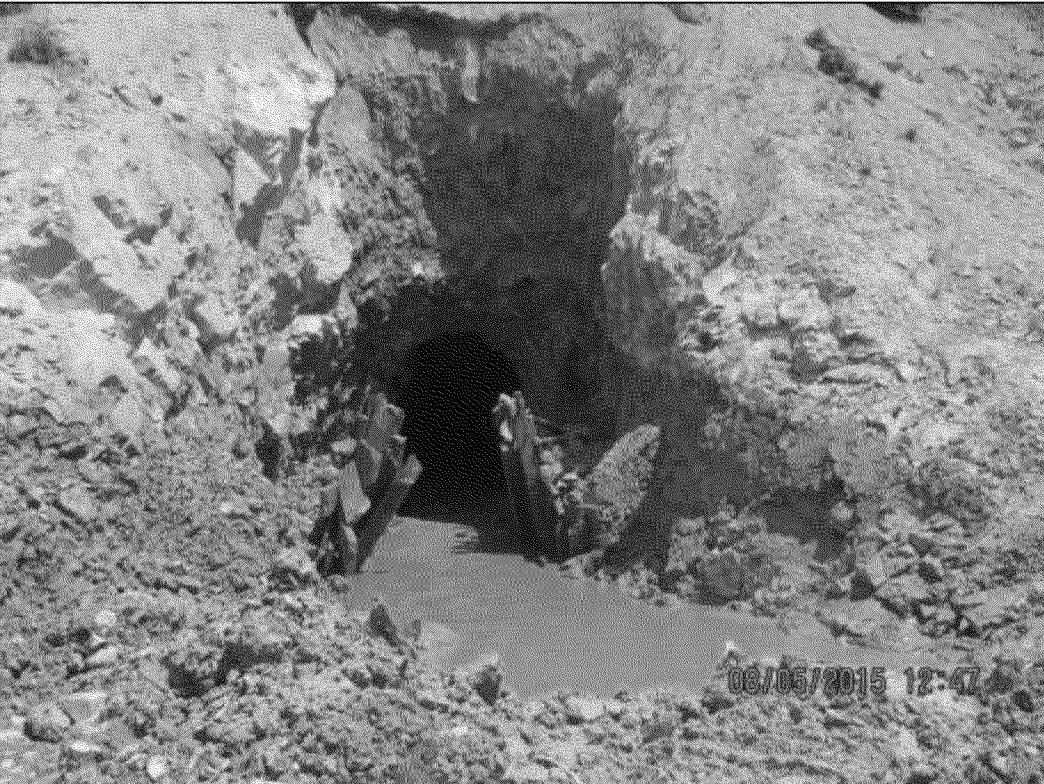
<b>Description:</b> No changes visible in adit structure or supports. Sloughing of materials inside the mine can be heard.			
Photo No. <b>40</b>	Date: 08/05/2015	<b>Direction Photo Taken:</b> South/Down

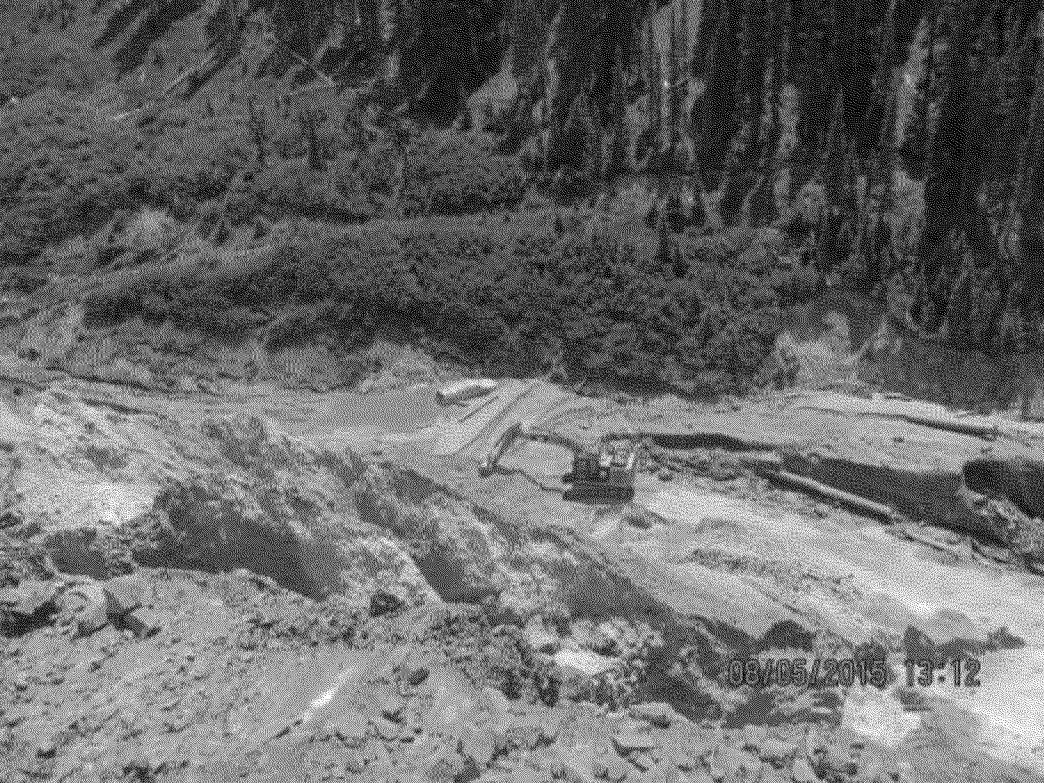
<b>Description:</b> Excavator progresses to washed out North Fork crossing.

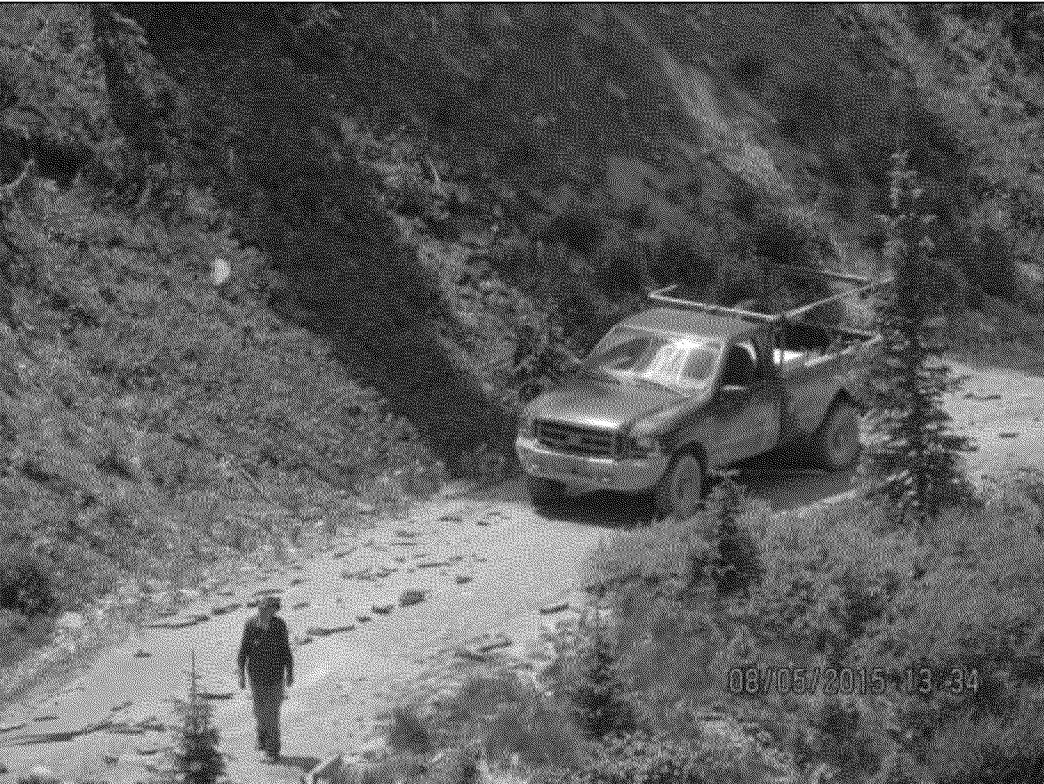
Project Name:		Site Location:	Project No.
Gold King Mine		Silverton, San Juan County, Colorado	0001/1408-01
Photo No. <b>41</b>	Date: 08/05/2015

Direction Photo Taken:	Southwest/Down		
Description:	Noted visitor to the site, unknown person, walked up to excavator at North Fork crossing and then back to vehicle.		
Photo No. <b>42</b>	Date: 08/05/2015

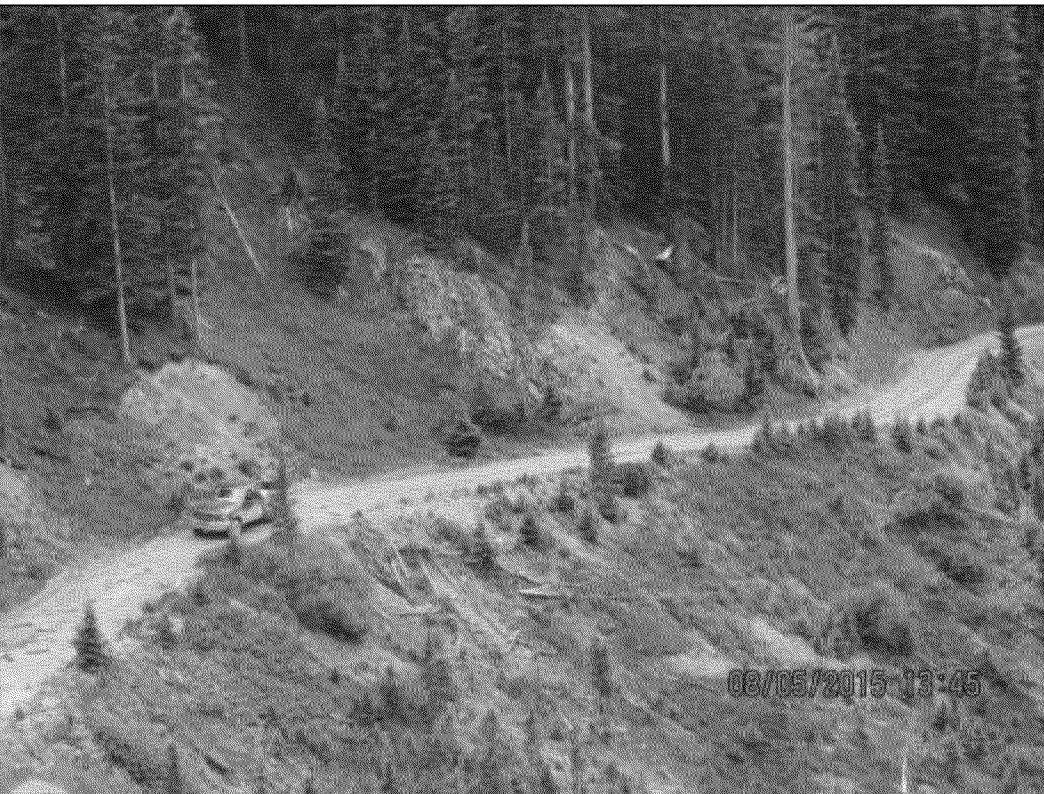
Direction Photo Taken:	Southwest/Down		
Description:	Visitor leaving.

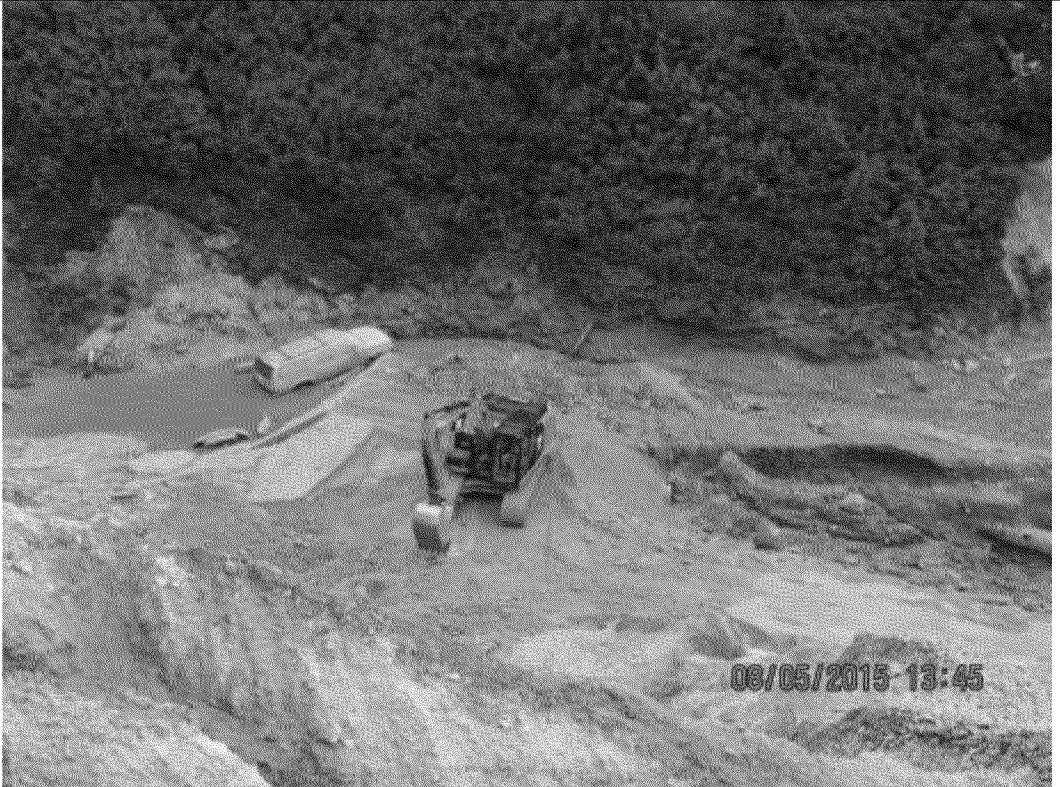
08/05/2015 13:45
<b>Description:</b> Excavator continues to fix access road. Continued high flow is slowing progress.			
Photo No. <b>44</b>	Date: 08/05/2015	<b>Direction Photo Taken:</b> East

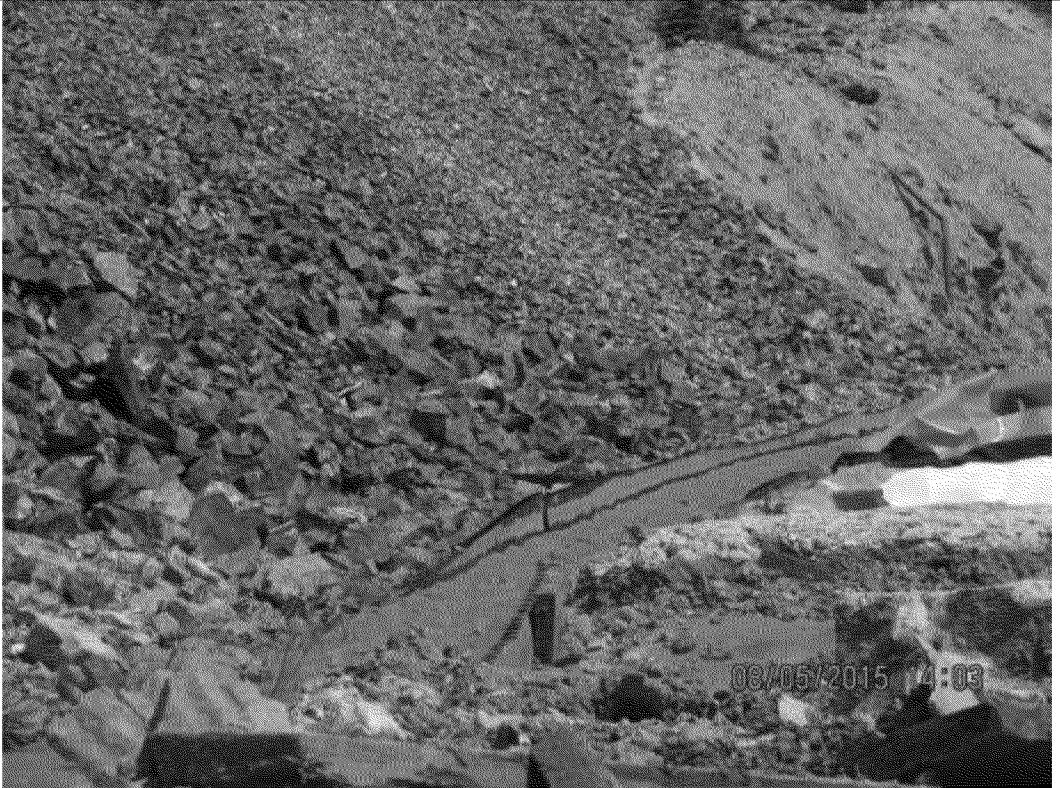
08/05/2015 14:03
<b>Description:</b> Half culvert flow continues to subside.

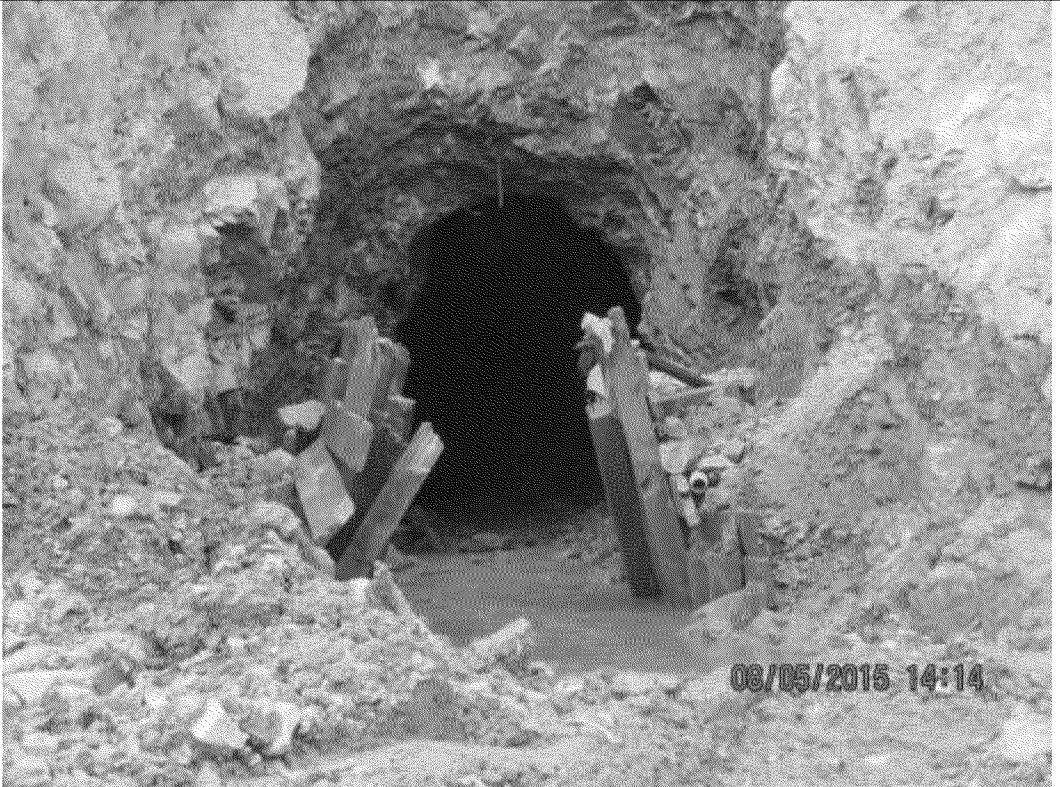
Direction Photo Taken:	North		
Description:	Water levels lowering at adit entrance, no visible changes to structure.		
Photo No. <b>46</b>	Date: 08/05/2015

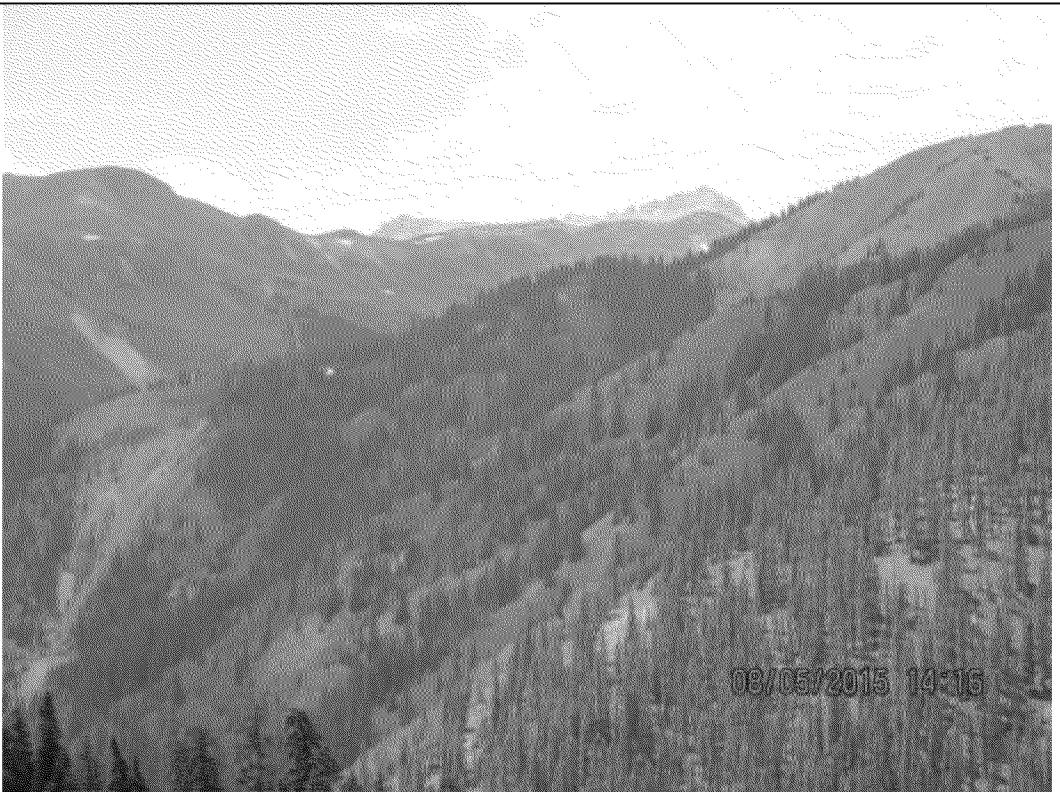
Direction Photo Taken:	West		
Description:	Flight for life Helicopter coming up the valley to pick up a person who crashed a vehicle on Corkscrew Pass, not related to this event.

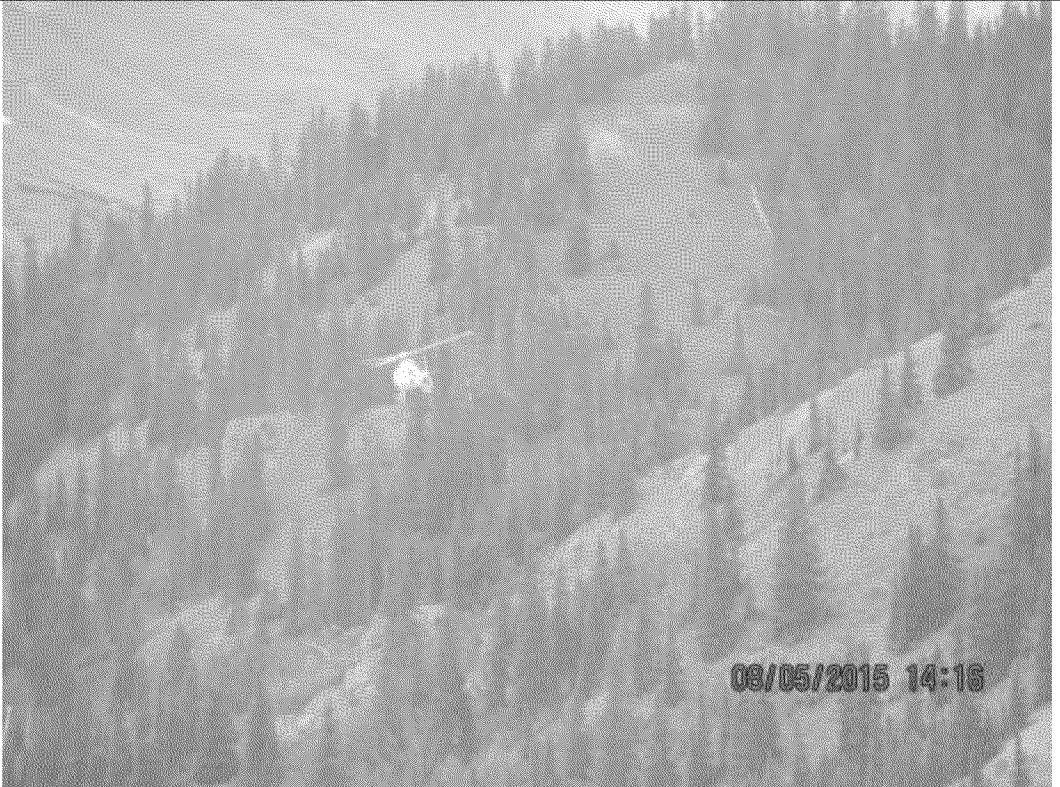
<b>Project Name:</b> Gold King Mine	<b>Site Location:</b> Silverton, San Juan County, Colorado	<b>Project No.</b> 0001/1408-01
<b>Photo No.</b> <b>47</b>	<b>Date:</b> 08/05/2015

08/05/2015 14:16
<b>Direction Photo Taken:</b> Southwest	<b>Description:</b> Close up of Flight for Life.
